United States Department of the Interior
National Park Service**National Register of Historic Places
Registration Form**

1. Name of Propertyhistoric name Jackson Township School Gymnasiumother names/site number Camden Elementary School Gymnasium of the Delphi Community School Corporation**2. Location**street & number 205 East Cumberland Street

Section number 7 Page 1 Jackson Township High School Gym in Camden, Carroll County, IN

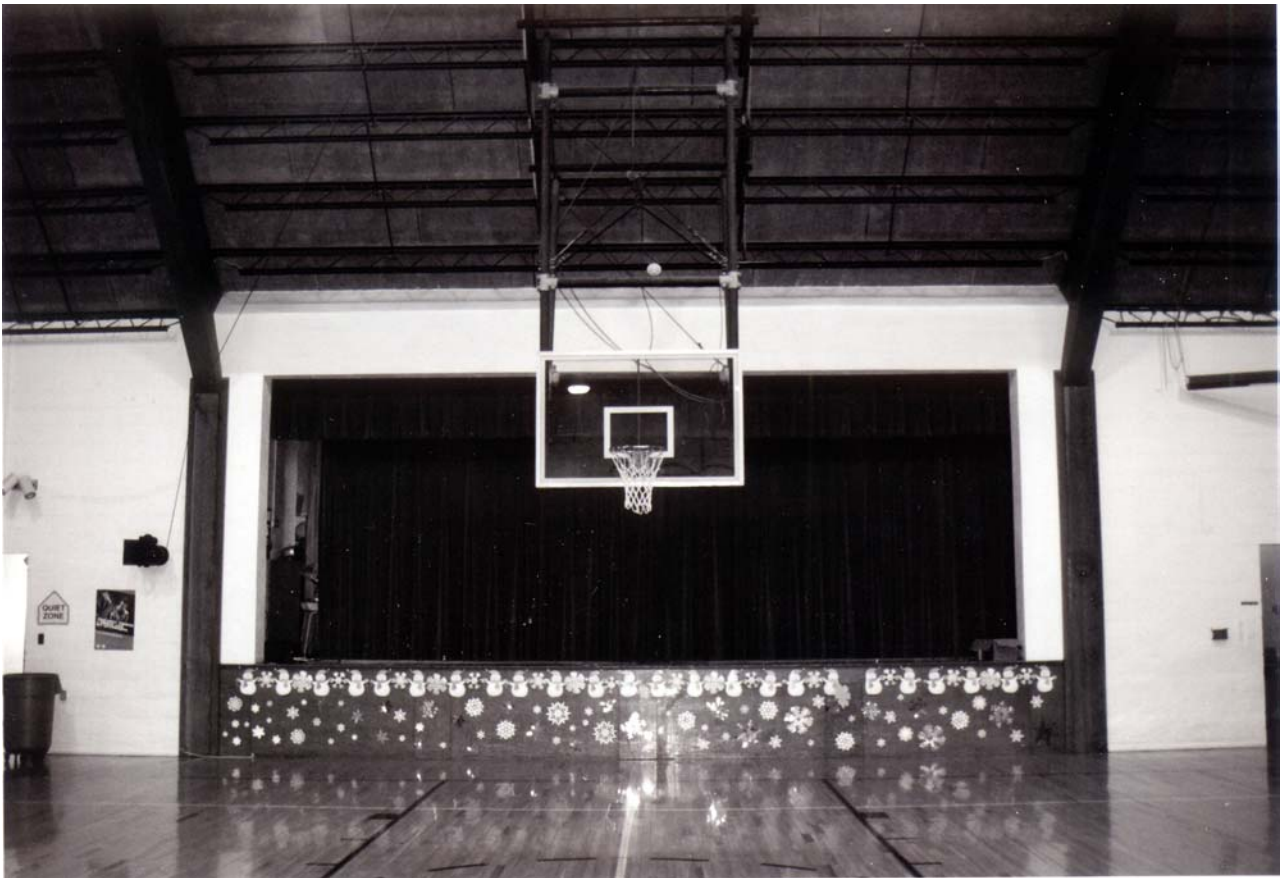
Photo 4

Art Deco was most popular from the 1920's through the 1940's and tried to express contemporary design and an artistic expression of the machine age with its simplicity and streamlined forms. The Jackson Township High School Gymnasium's Art Deco components are characterized by inset squares along the top of the entrance. Repetition of geometric shapes and patterns is a common element of Art Deco structures. Long, sleek simplified buttresses on the south side entrance represent columns for a recessed two-story portico. The use of glass blocks in the second floor windows above the entrance is another common Art Deco feature. The vertical emphasis of the building is enhanced with steel casement windows and walls of smooth concrete blocks. The interior of the gym features original wooden bleachers, steel ceiling trusses and custom made wooden arches supporting the barrel vaulted ceiling (photos 4 and 5).
